REPLACING THE CHAIN MAY NOT ALWAYS BE ENOUGH

Easily check your drive sprocket or chain ring and thus ensure that your chain is not unnecessarily strained by worn-out teeth.

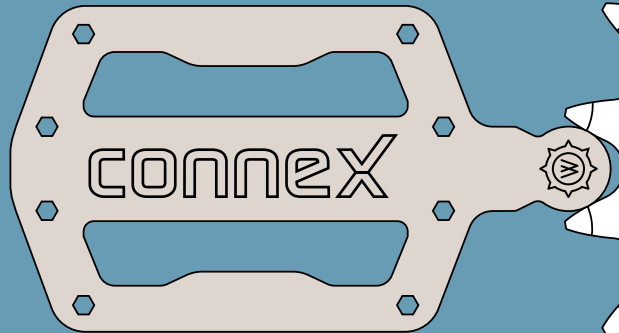
If the wear indicator does not fully fit into the gap between two teeth and a small gap remains visible, the gearing is still in a good condition.

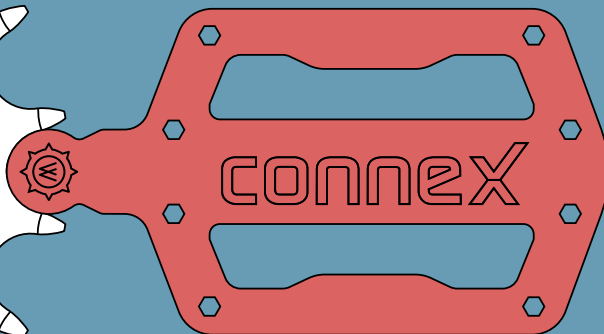
If the indicator is completely in contact and there is no gap, the sprocket/chain ring should be replaced together with the chain.
